Various Volkswagen, Audi, SEAT, Škoda and Cupra models equipped with four-wheel drive and a 5th generation Haldex coupling.

Repair Kit Rear Axle Drive for differential and Haldex unit

Problem

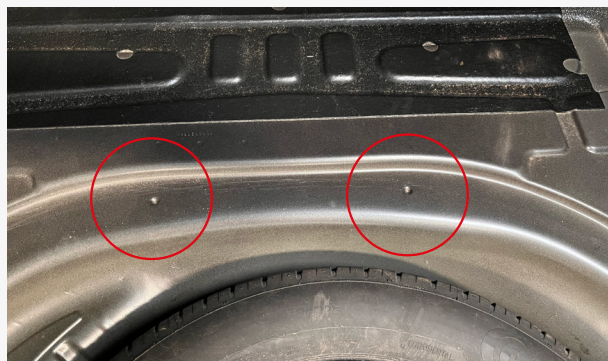
Figure 1

To access the three retaining bolts, one can be reached from underneath the vehicle, while the other two can only be accessed by drilling holes in the floor of the luggage compartment at the designated points (Fig. 1) provided by the vehicle manufacturer for this purpose.

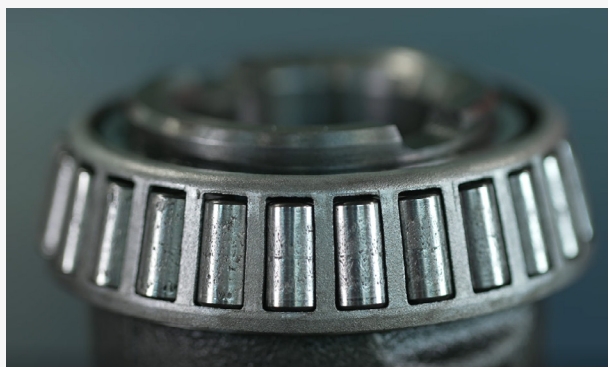
Figure 2

Remove all housing bolts and split the two halves of the housing, then remove the differential and crown wheel assembly. Inspect the taper roller bearings for pitting and damage. (Fig.2)

The rear differential taper roller bearings have become pitted and worn. This could be due to the rear differential oil not being replaced at the set service intervals or the incorrect oil has been used.

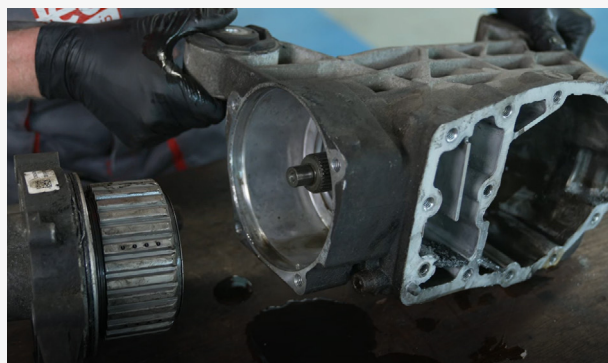
Figure 3

Remove the Haldex clutch unit from the differential housing and inspect. Then check the smoothness of operation of the pinion bearing by turning the shaft by hand. (Fig.3)

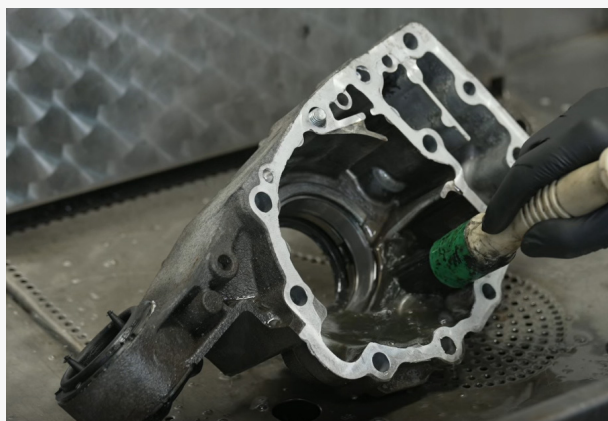
Figure 4

With the differential unit stripped down, remove the two magnets from the fluid chambers and clean any debris from the housing and differential. (Fig.4)

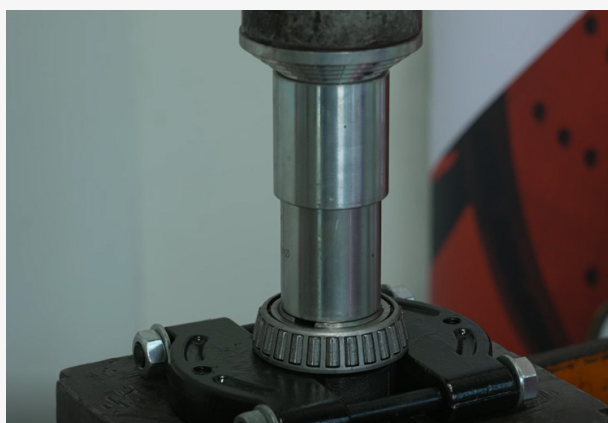
Figure 5

Press off both taper roller bearings with a hydraulic press. Clean all mating surfaces and press in the new bearings, followed by the new bearing cups into the housing, remembering to install the shims first. (Fig.5)

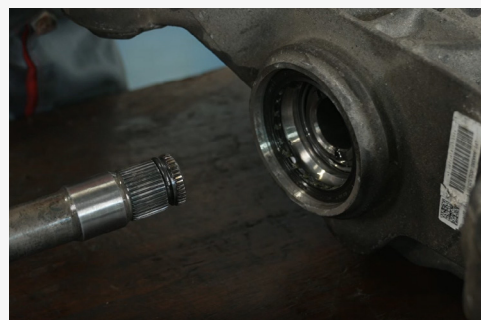
Figure 6

Fit the new circlips to the driveshafts and install them into the differential. (Fig.6)

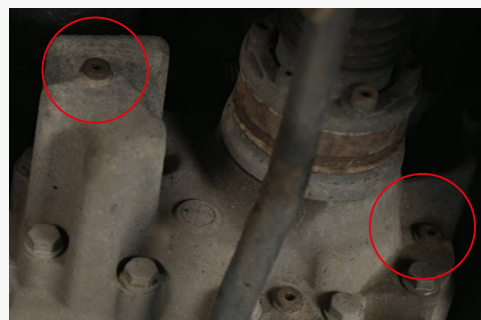
Reinstall the repaired differential unit to the vehicle and fill the differential and Haldex unit with fresh oil from the kit, ensuring the correct oil is applied to the correct area. (Fig.7)

Figure 7
Note: The image above shows the oil filler/level plug locations. Haldex (left) and differential (right).
